## Agricultural Impact Study Highlights

An agricultural impact assessment has evaluated the potential impacts on agriculture from the proposed Shantz Station Pit and identified mitigation measures to reduce those impacts on surrounding agricultural uses. The assessment reviewed two areas: a primary area that encompasses the proposed licence area and lands 120 metres outside it; and a secondary area within a one-kilometre radius of the proposed pit licence area.

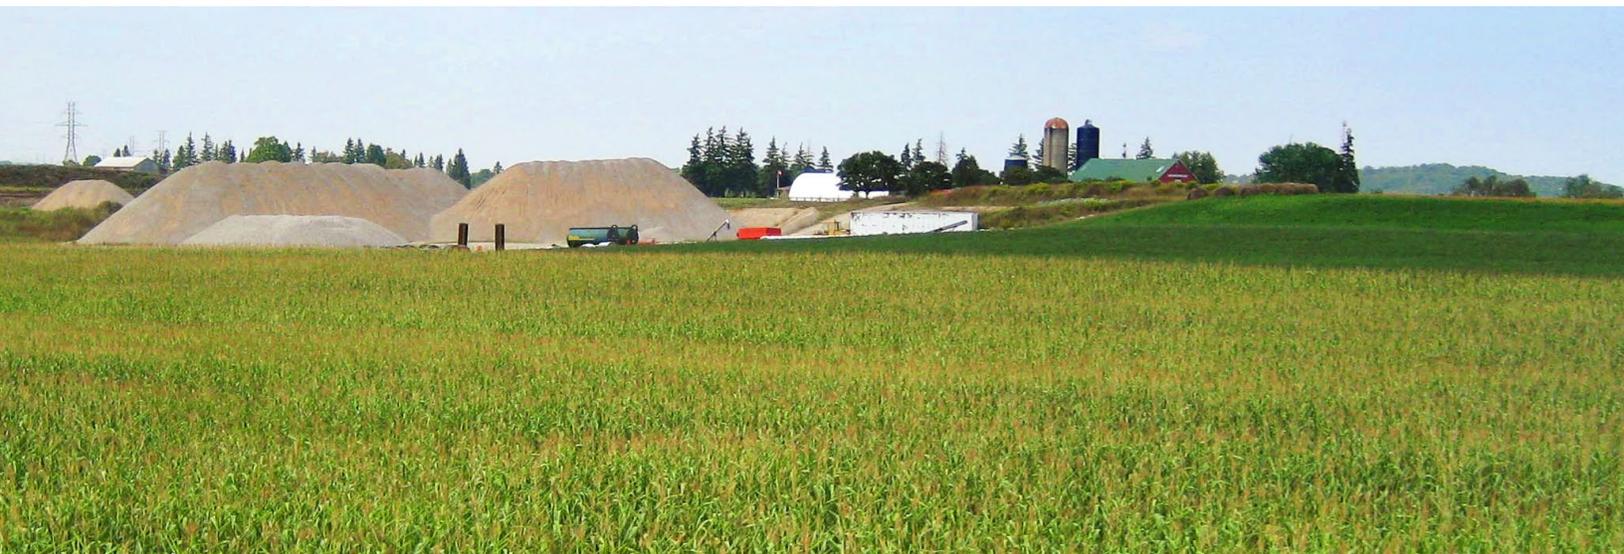
**Crop cultivation and aggregate extraction are happening concurrently at Capital Paving's Whistle Bare Pit in North Dumfries, similar to what is being proposed for the Shantz Station Pit. In the photo above, the fields in the foreground as well as along the slope to the right have been rehabilitated back to farmland after sand and gravel was removed.**

Capital Paving is proposing to extract sand and gravel in five phases (or areas of the site), with each area rehabilitated shortly after moving to the next phase. In total, 96% of the total land area would be rehabilitated back to a Class 2 or better soil capability.

The final study report includes illustrated examples of former Capital Paving pits that have been successfully rehabilitated back to agricultural uses, including the Holman Pit in Guelph Eramosa Township, the Wellington Pit in Puslinch Township and the Whistle Bare Pit in the Township of North Dumfries.
